Accessibility of Shared Space by Visually Challenged People

Bart J.M. Melis-Dankers¹, Else M. Havik¹, Frank J.J.M. Steyvers²,
Helen Petrie³ and Aart C. Kooijman¹

ABSTRACT

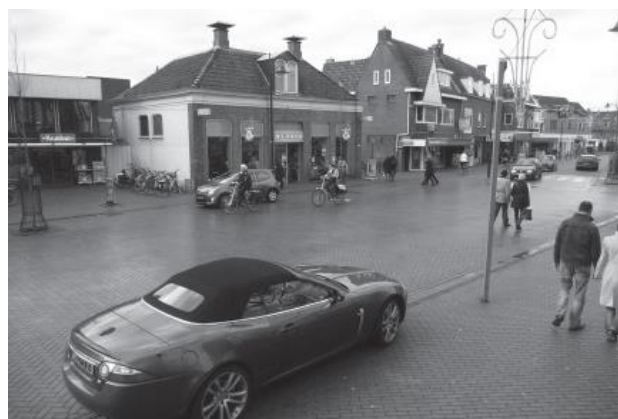
Figure 1. Example of Shared Space in the Netherlands. All traffic flows (e.g. cars, bicycles and pedestrians) mingle.
